Crystal River Nuclear Plant  
Docket No. 50-302  
Operating License No. DPR-72

Subject: LICENSEE EVENT REPORT 50-302/02-002-00

Reactor Trip Due To Substation Generator Output Breaker Relay Mis-operation

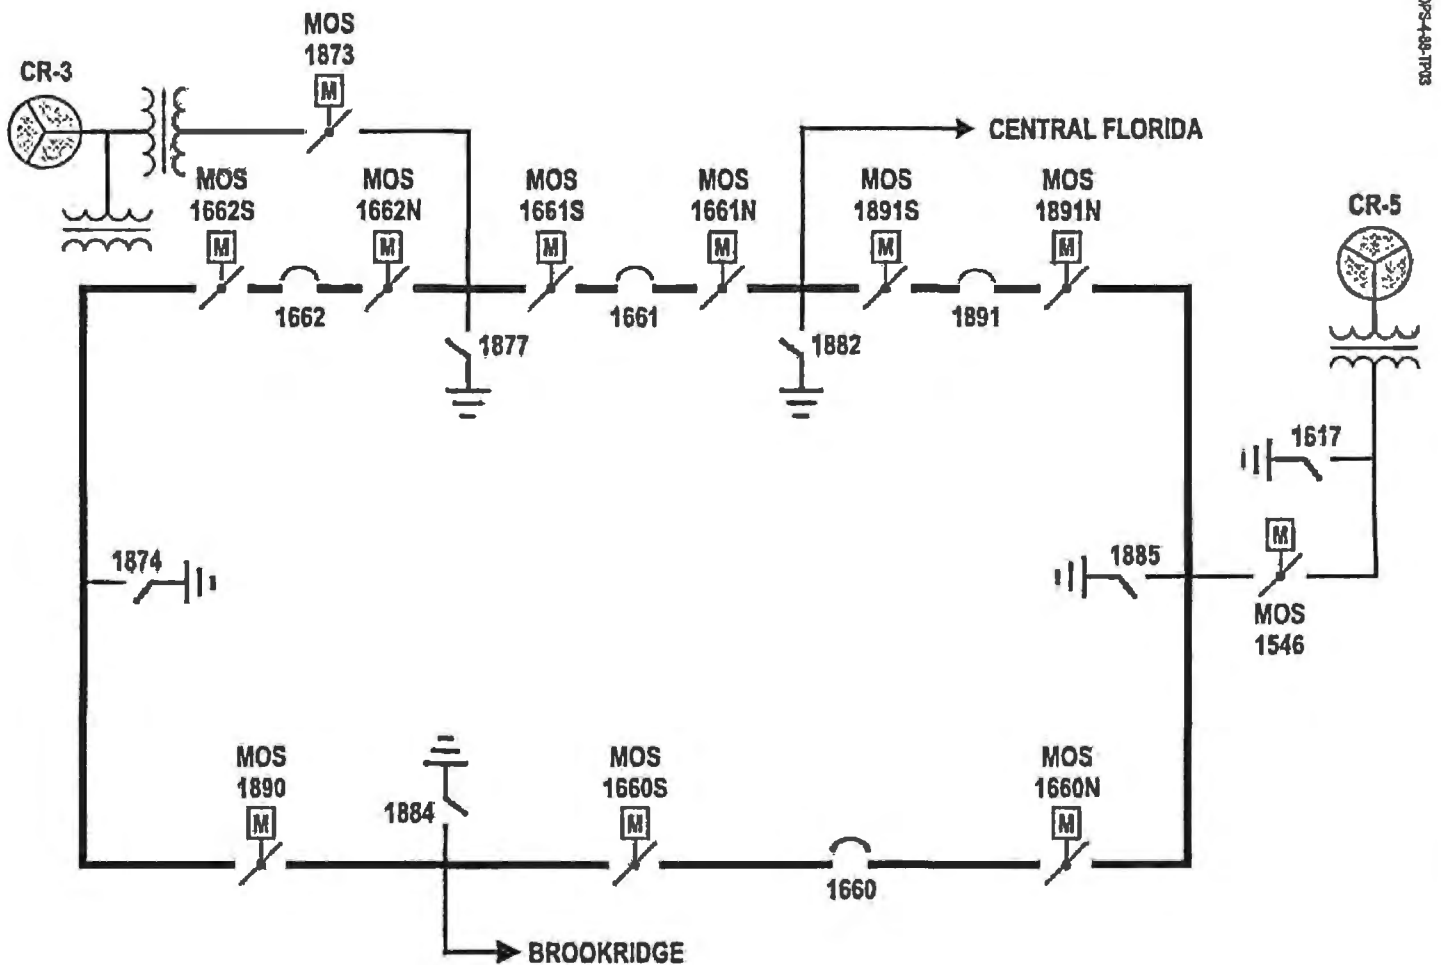
## DRAWING #1

CR-3 connects to the 500KV substation through breakers 1661 and/or 1662 (see Drawing #1 – 500KV Substation Simplified Drawing). The 500KV substation [FK] also includes the incoming feeder from CR-5 (fossil generating plant), and outgoing transmission lines [FK, CBL] to Central Florida and Brookridge substations. Breakers 1661 and 1662 are designed to separate CR-3 from the grid under normal and abnormal conditions. Various relaying schemes associated with breakers 1661 and 1662 are designed to assure protection for the CR-3 main generator and 500KV substation from electrical faults.

CR-3 experienced a turbine trip and subsequent anticipatory reactor trip due to unexpected operation of breaker 1662 during system protective relay [FK, RLY] testing. Normal operating configuration would have required both 500KV generator output breakers 1661 and 1662 to open. However, breaker 1661 was out of service for maintenance and modification work. Post modification testing being performed was associated with relaying schemes for breaker 1661 and recent improvements made in the 500KV substation.

The cause for opening of 500KV substation generator output breaker 1662 was mis-operation of an Agastat 7024AC time delay relay contact [FK, 21] used to remove power from the 39E phase-to-phase fault relay and 39F phase-to-ground fault relay. Upon removal of the supply power to the Agastat 7024AC time delay relay, the relay contact created a voltage spike of the 39E relay power supply.

Engineering Change EC 50696, Revision 1, has been implemented. The way the 39E and 39F relays are disabled when the PT potential signal from the Central Florida transmission line is unavailable has been changed to prevent a repeat of the inadvertent trip of the CR-3 500KV substation generator output breakers. Previously, an Agastat 7024AC time delay relay removed the 125 volt direct current power from the 39E and 39F relays at 1.5 seconds after the loss of potential from the Central Florida transmission line potential transformers. The Agastat relay has been replaced by a multi-function programmable relay to block the trip signal from the 39E and 39F relays in addition to de-energizing input power to the relays. The new relay has an instantaneous pick-up set of contacts for energizing the power supplies and a 0.5 second delay for the trip signal when the relay is energized. When the new relay is de-energized, there is a 1.5 second delay for the trip signal and a 2 second delay for de-energizing the power supplies. The trip signal will effectively be blocked (0.5 seconds) both when applying control power and when removing control power from the two relays (39E and 39F). The 0.5 second blocking function will allow the 39E and 39F relay power supplies to energize (de-energize) without propagating a spurious trip of breakers 1661 and 1662.
